EVALUATION OF NEW SURFACE PREPARATION  
AND  
COATING REPAIR TECHNIQUES IN BALLAST TANKS

JULY 1990

Prepared by  
Associated Coating Consultants  
in Cooperation with  
National Steel and Shipbuilding Company  
San Diego, California 92138

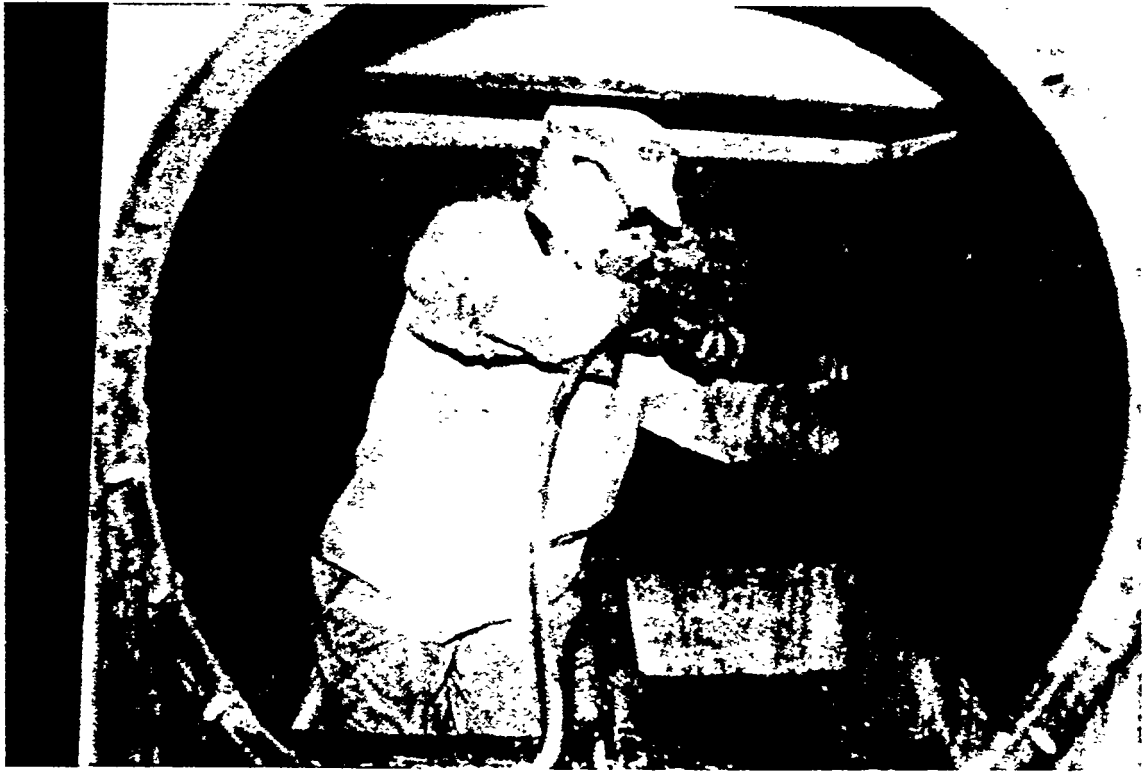
Figure 1.8: Hand Power Tool Cleaned Surface Prior to Coating

After two years, the coating system applied in this tank over a combination power and hand tool cleaning techniques seems to be performing as well as or better than the same system applied over abrasive blast cleaned steel. There is some coatings breakdown along the lower section at the interface between the previously coated and bare steel areas. This condition is not unusual when applying a new coating over the feathered edge of an old coating. The new coating has a tendency to lift the old coating. The back and sides of the tank have from one to three percent failure. The top has less than one percent failure, and the bottom has less than one percent except for some stiffener edges which are beginning to fail. Figure 2.8 is a photograph of the degree of hand and power tool cleaning prior to coating application.
